**DEPARTMENT OF TRANSPORTATION****DIVISION OF ENGINEERING SERVICES**

Office of Structural Materials

Quality Assurance and Source Inspection

Contract #: 04-0120F4Cty: SF/ALA Rte: 80 PM: 13.2/13.9File #: 69.15**SOURCE INSPECTION REPORT****Resident Engineer:** Pursell, Gary**Address:** 333 Burma Road**City:** Oakland, CA 94607**Report No:** SIR-002208**Date Inspected:** 15-May-2010**Project Name:** SAS Superstructure**OSM Arrival Time:** 700**Prime Contractor:** American Bridge/Fluor Enterprises, a JV**OSM Departure Time:** 1900**Contractor:** Zhenhua Port Machinery Company, Ltd (ZPMC), Changxing Island **Location:** Shanghai, China**Quality Control Contact:** Mr. Don Walton**Quality Control Present:** Yes No**Material transfer:** Yes No N/A**Sampled Items:** Yes No N/A**Stock Transfer:** Yes No N/A**OK to Cut:** Yes No N/A**Rebar Test Witness:** Yes No N/A**Delayed/Cancelled:** Yes No N/A**Other:** Coating Inspection**Bridge No:** 34-0006**Component:** See Below**Bid Item:** 77, 78, 79**Lot No:** B #204**Summary of Items Observed:**

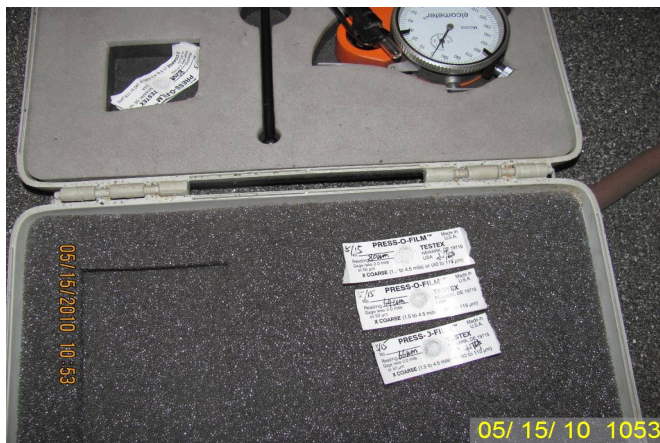
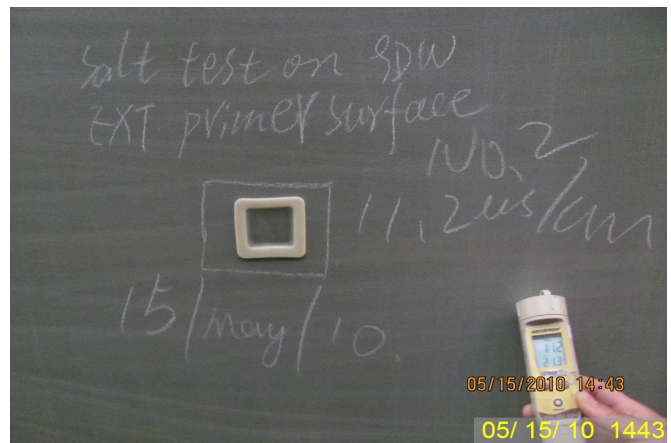
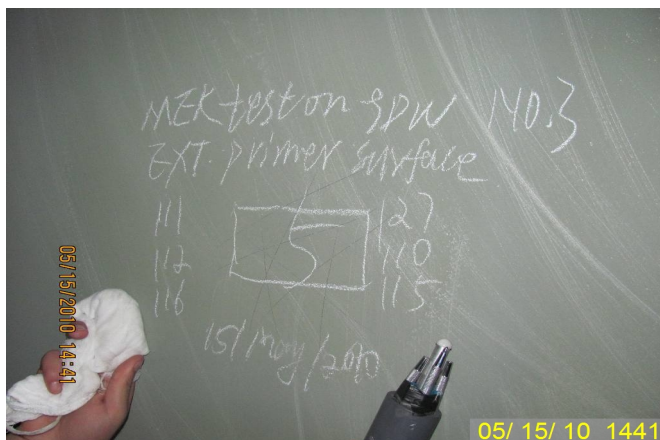
4. An inspection was requested on the OBG external Segment 9DW external surfaces for DFT Check, Residual chlorides test and MEK test, vide request no. 3313 at Painting workshop no. 1 . This Caltrans inspector observed, ABF inspectors Mr. Sun , Mr. Wei and Mr. Shi stone performing said inspection check . This was found accepted by ABF Inspectors for Mist coat. The results of MEK test found to be in the Grade of 5 which is acceptable as per contract documents. The results of X3 Salt test value found to be in the range of 6.8 to 11.2 us/cm which was conducted in 3 places of the external areas of the segment. The ambient conditions were monitored and found to be 6.3 deg. above dew point. The relative humidity found to be 65.3%. International protective coatings technical service representative Mr. Li peng was found present during the course of this inspection process. The photograph of Salt test and MEK test conducted in segment 9 DW is attached.
